# High-purity Magnesium Coating on Magnesium Alloys by Vapor Deposition Technique for Improving Corrosion Resistance

Microstructures in coated magnesium alloy with high purity magnesium fabricated by applying a vacuum deposition technique were investigated. Moreover, relationships between microstructures in coated and un-coated magnesium alloys and corrosion behaviors were interpreted by *in-situ* laser microscopic observations during salt immersion tests. Magnesium with 3N-grade and AZ31 magnesium alloy were used for an evaporation source and a substrate for deposition. Temperature of the substrates was changed resulting in change in temperature profile in a furnace in order to optimize deposition coating conditions for obtaining homogeneous microstructures and thickness in deposited layer. The coated specimen revealed superior corrosion resistance to those on 3N-Mg, AZ31 and AZ91E alloys, and comparable to that on 6N-Mg in salt immersion tests using 3% NaCl solution at 300 K for 587 ks. *In-situ* observations showed that inhomogeneity in microstructures, such as second phases and grain boundary segregations, deteriorate corrosion resistance in magnesium alloys. Therefore, pure m

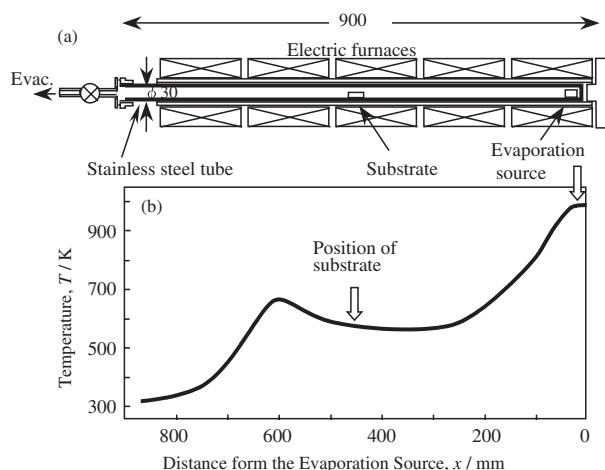
Fig. 1 Schematic illustration of the deposition furnace (a) and temperature profile in the furnace (b).

Optimization of deposition conditions was carried out using the previous furnace which is schematically illustrated in Fig. 1(a). The optimum temperatures for the evaporation

source and the substrate were about 983 and 573 K, respectively. The temperature profile is shown in Fig. 1(b). There was a bump between the substrate and the evacuating end. When a profile without the bump was applied for deposition coating, the side surface opposite to the evaporation source was not coated.

Microstructures of the deposited surfaces corresponding to the cross sections in Figs. 2(a)–(d) are shown in Figs. 3(a)–(d), respectively. Grain sizes varied from about 5 to 20  $\mu\text{m}$  depending on the surfaces, but any defects were not observed. As reported in the previous paper,<sup>6</sup> coating at higher substrate temperature results in deposition of grains with larger sizes. Small grains in the side surface opposite to the evaporation source, (c), imply that the temperature was lower or density of magnesium vapor was lower than those in other surfaces. The latter case seems to be valid referring to the temperature profile in Fig. 1.

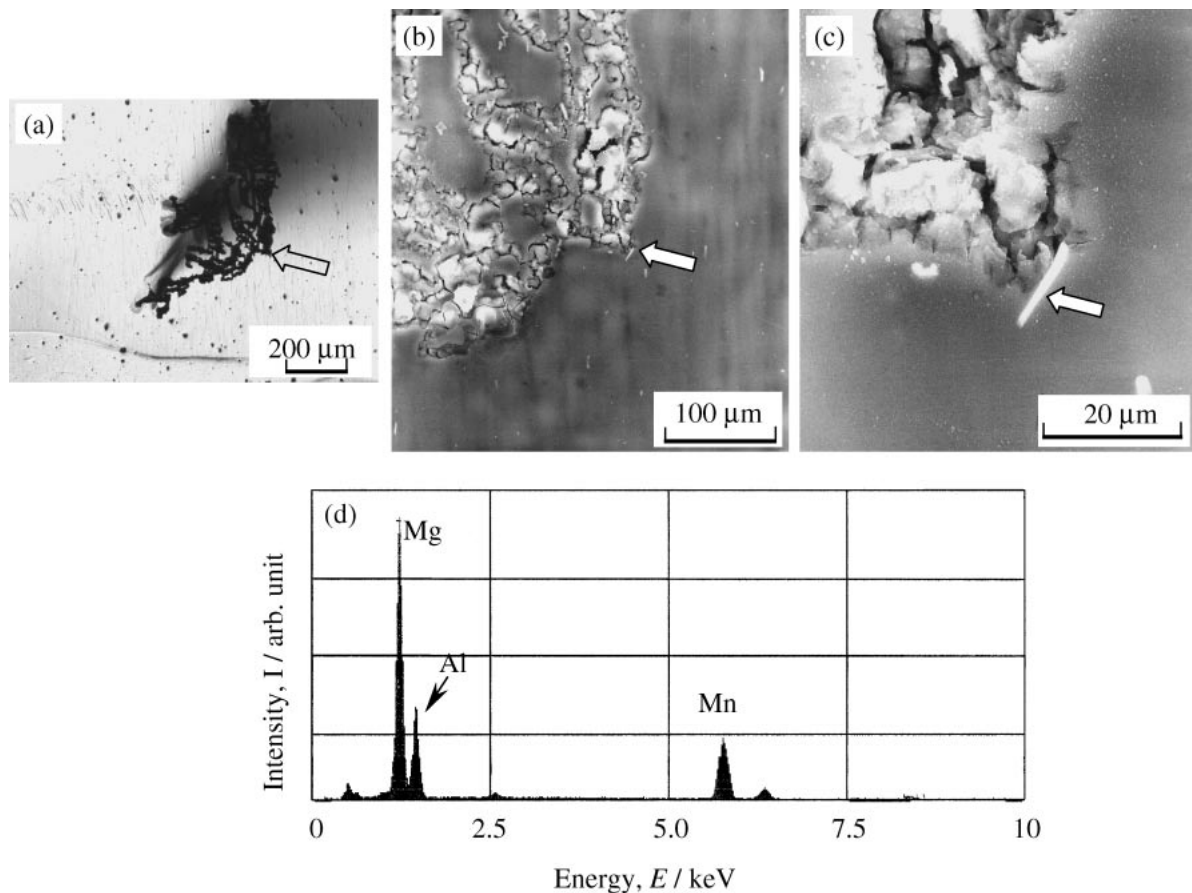
Fig. 10 *In-situ* observation of a filiform corrosion in the un-coated AZ31 alloy (a). SEM image with low and high magnifications (b) and (c), respectively, of the area in (a) after salt immersion test. The arrows in (a), (b) and (c) indicate the origin of the filiform corrosion. EDX spectrum taken at the inclusion indicated in (c).

As reported in the previous papers,<sup>8,13)</sup> filiform corrosion occurs on the un-coated 3N-Mg and the un-coated AZ31 alloy. *In-situ* observation of filiform corrosion on the un-coated AZ31 alloy is shown in Fig. 10(a). The filiform corrosion occurred at the position indicated by the arrow and then advanced remaining tails. Corrosion reaction occurred at the heads of filiforms, while the tails were inactive. After the *in-situ* observation, the specimen was rinsed and dried, then observed by SEM. The area around the origin is shown in low and high magnifications in (b) and (c), respectively. There can be seen that the filiform corrosion occurred near the inclusion indicated by the arrows. Energy dispersive X-ray analysis showed that the inclusion was a compound with Al-Mn system.
